Automatic Tensioning Device TENSOREX C+

Maintenance and operating control

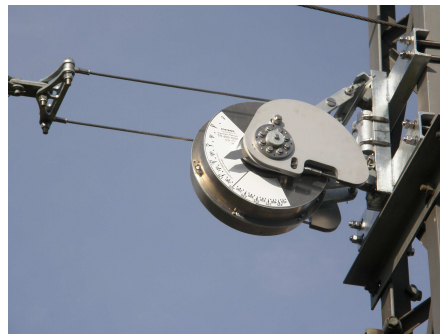
- Basically the device C+ does not require any particular maintenance procedure or operations due to the following reasons:
 - Ropes are stainless steel made and therefore do not require to be greased
 - Bearings of the pulleys are pre greased and completely sealed: no need to be greased at all
 - Pulley are aluminium made and therefore they do not require any particular maintenance cycle
